February 2001

# Mill Creek

Flood Control Project  
Radial Gate Investigations

13. ABSTRACT (Maximum 200 words) This report is an evaluation of the overall condition of the spillway tainter gates at Mill Creek Flood Control Project, Walla Walla, Washington

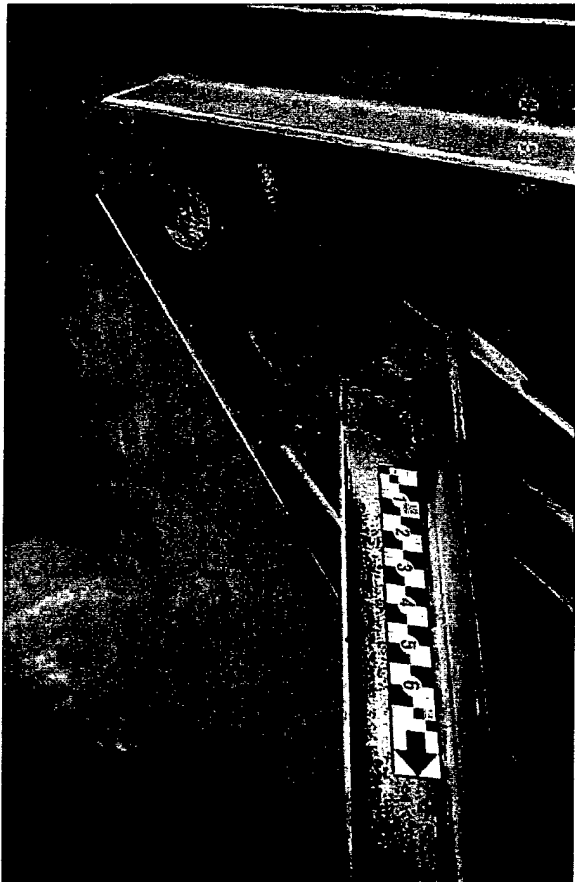
***Photo 2 - Radial strut and diagonal brace connection to trunnion showing light corrosion.***

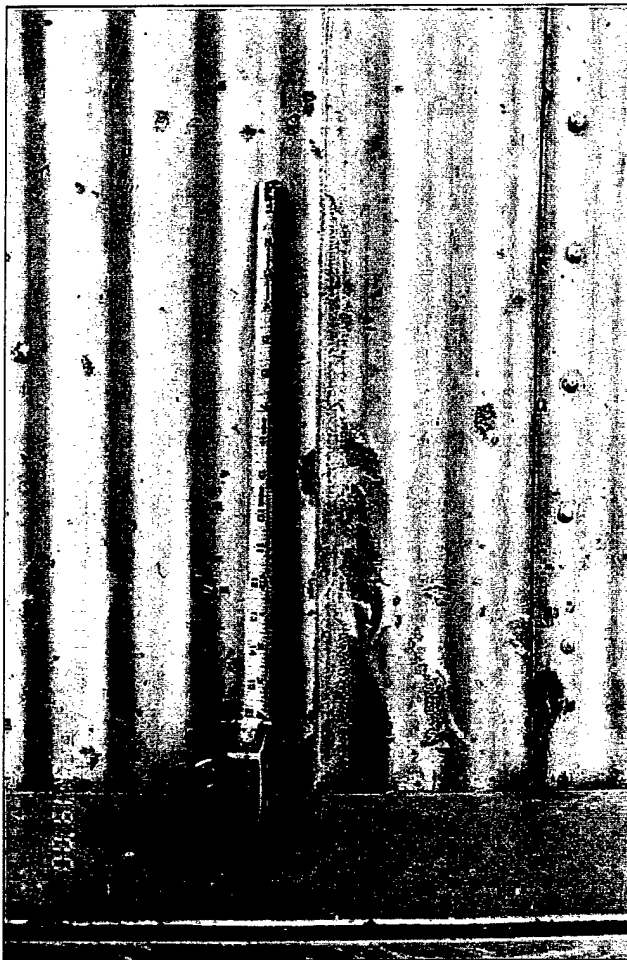
The skin plate is comprised of three sections of corrugated, galvanized steel with the corrugated ribs running in the vertical direction. The plate is  $\frac{3}{32}$  inch thick, with a span between corrugations of  $2\frac{3}{4}$  inches and a section depth of  $\frac{3}{4}$ ". The skin plate is in very good condition. There are spots of delaminated paint, however, very little corrosion is visible through the galvanizing.

*Photo 3 - Downstream surface of skin plate showing typical worst case delamination.*

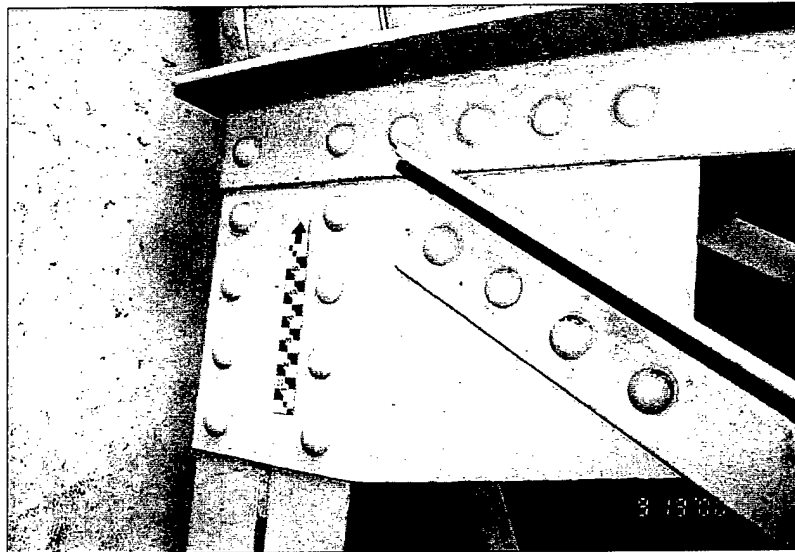
All of the connections on the gate were in very good condition. Small amounts of rivet head loss due to corrosion were found at isolated locations, however, the rivets were in generally excellent condition.

*Photo 7 - Typical condition of rivets.*

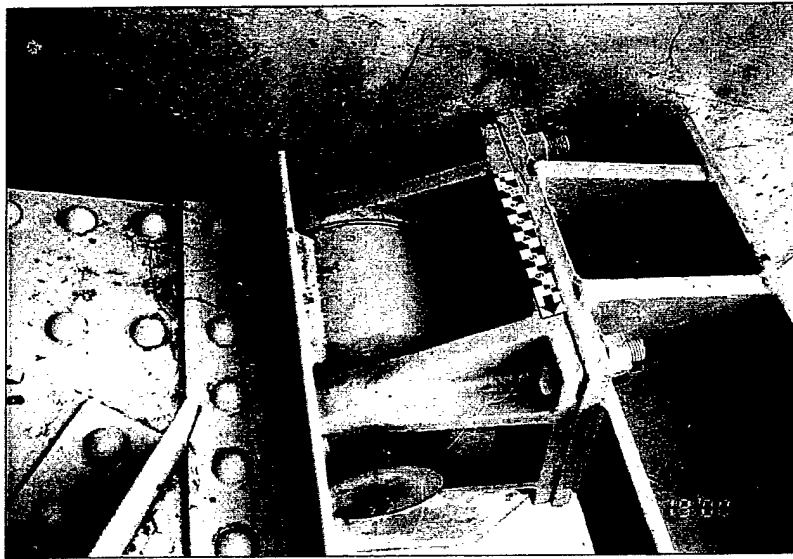
The trunnions at all of the gates are in generally good condition and appear well lubricated. There are isolated spots of light surface corrosion on the trunnion hub or yoke at some of the trunnions, however, no section loss is visible. Photo 8, below, shows the typical condition of the trunnions.

***Photo 8 - Typical condition of trunnion.***

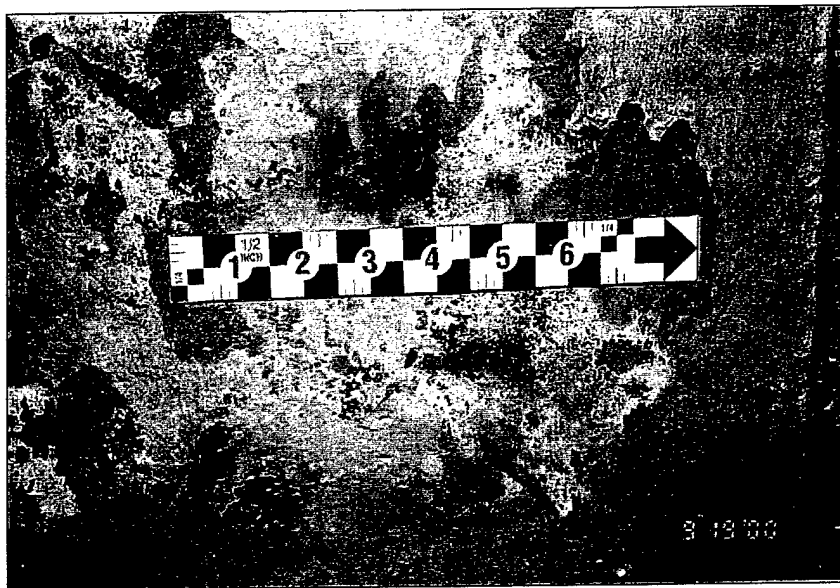
Photo 11 shows a close-up of the delaminated paint and moderate corrosion typical on the gate faces. Photo 12 shows a close-up of moderate corrosion near the bottom seal on Gate 2 (Note: good condition of rivets and bolts).

***Photo 11 - Delaminated paint and light to moderate corrosion, typical on all gates.***

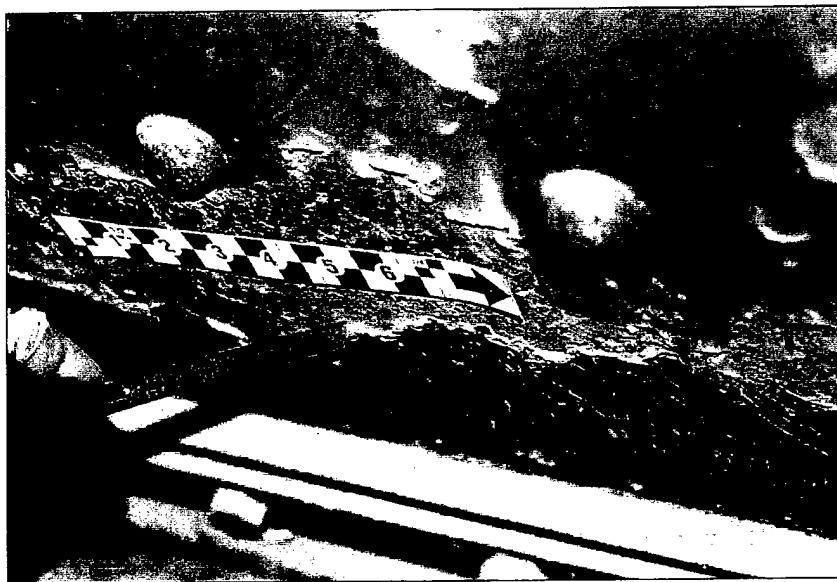
***Photo 12 - Moderate corrosion on skin plate at bottom seal.***

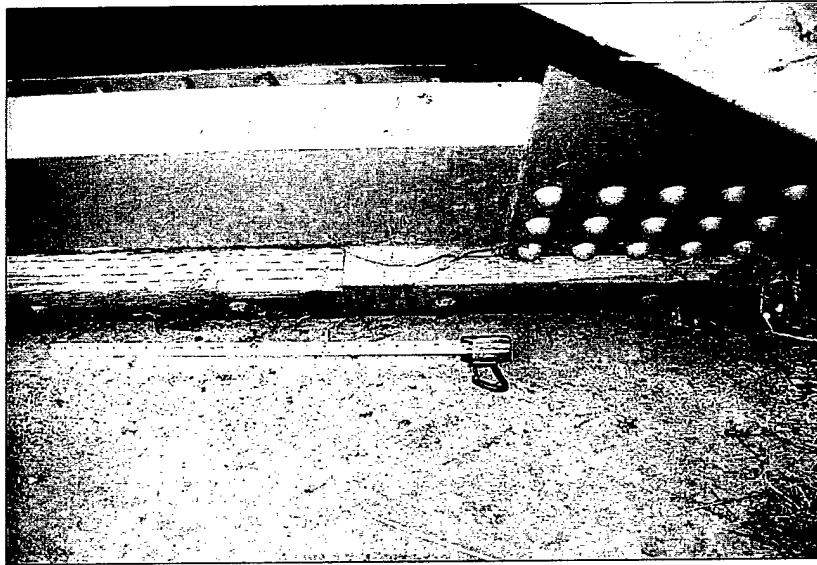
Timber bumpers are installed at the bottom of the gate on the downstream side. The timbers are bolted to the web of the bottom horizontal girder. At all of the gates, on at least one end, the timbers are split or deteriorated. See photo 15 below, typical.

***Photo 15 - Splitting of bottom timber at right side (looking upstream) of Gate 1.***

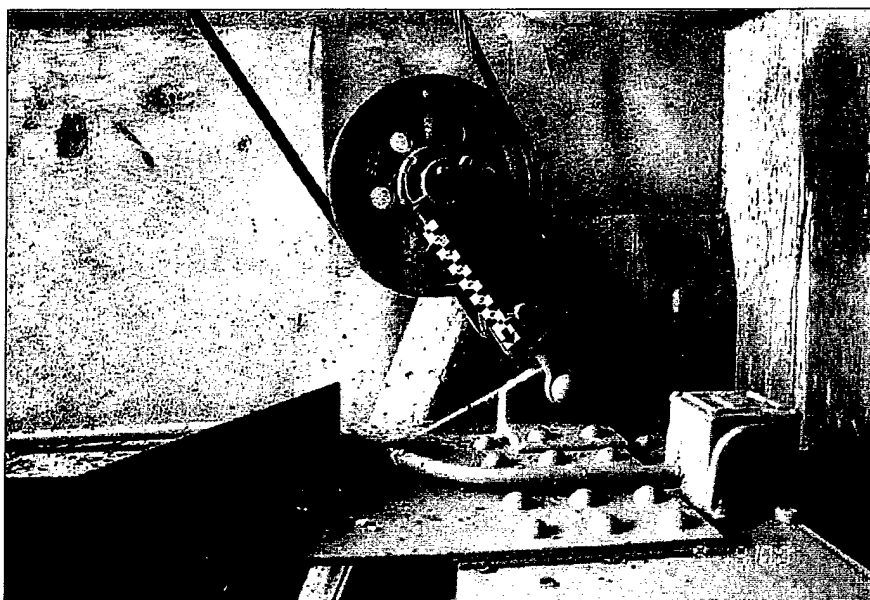
External portions of the hoist equipment, support platforms and gate connections were visually inspected for signs of excessive corrosion, wear or damage. The hoist and hoist machinery are in generally good condition. All of the gates were raised to approximately two feet open in order to check for racking and to allow access to the upstream side. Racking measurements were made at the left and right side of the gates, between the bottom corner of the bottom horizontal girder and the top of the spillway. There is no apparent racking occurring at any of the gates and all measurements were within 1/8-inch from one side to the other. Measurements for each of the gates are given in Table 1, below. The 2:1 reduction, lifting pulleys on the top of the gates were in good condition with only light corrosion on some of the wheels or linkages. See photo 17 below.

*Photo 17 - Hoist reduction pulley at top of gate, typical.*

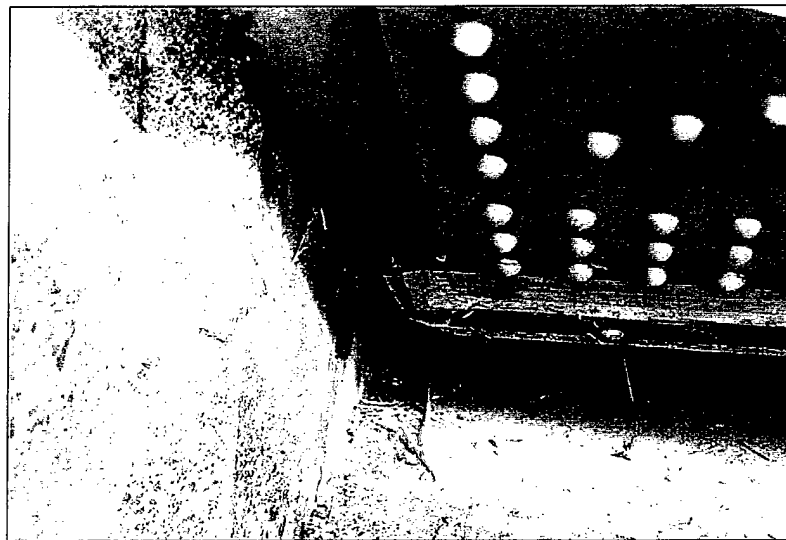
- The bottom strut along the right frame at the bottom girder connection is moderately corroded and deformed. See photo 18.

***Photo 18 – Bottom strut, right frame at bottom girder connection. Bottom strut is deformed and wooden bumper cracked.***

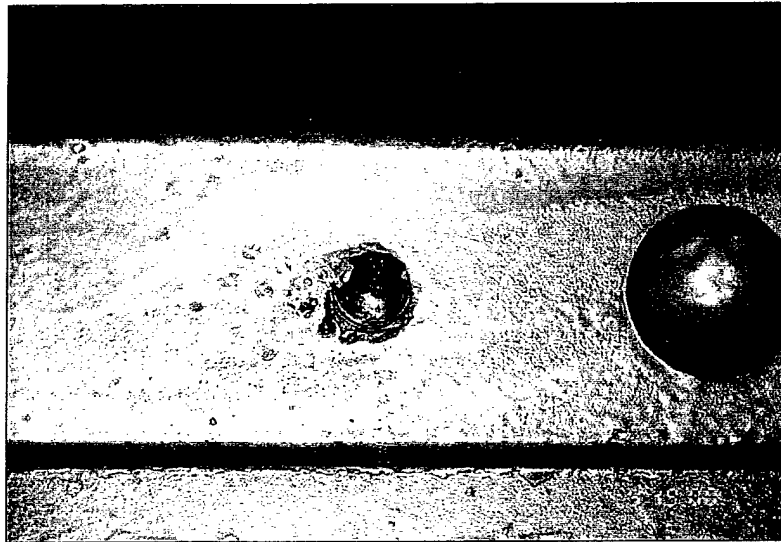
- There are two bolts missing between the top girder and the top seal. Some bolts appear to have been tack welded while others were not. One bolt was loose enough to turn by hand. See photo 20.

***Photo 20 - Bolt at top girder to top seal. Note broken tack weld.***

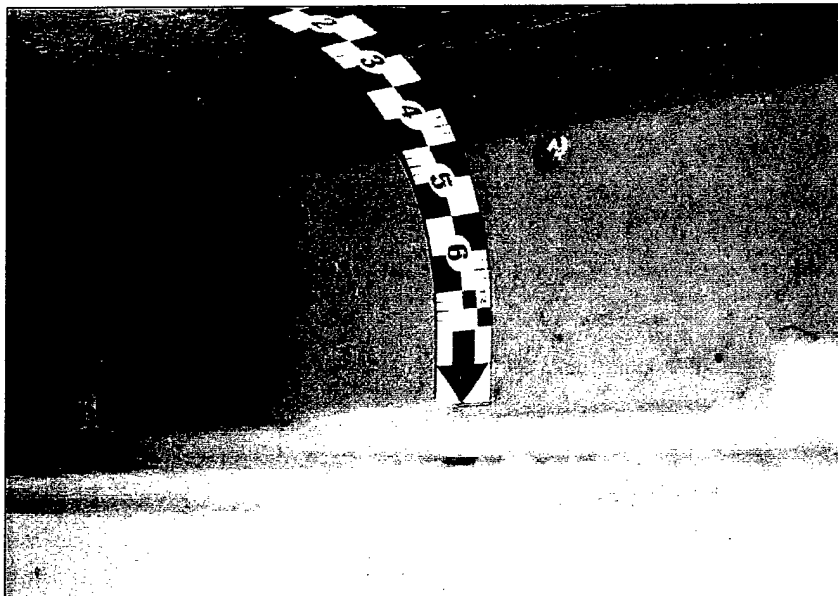
- There are five missing bolts at the top of the gate. The bolts attach the upstream top seal bracket to the skin plate and the web of the top horizontal channel. There is no apparent distress or evidence of leakage due to the missing bolts. See photo 22 below.

***Photo 22 - Missing bolt at top seal bracket, typical of five locations. Note: presence of washer without bolt head.***

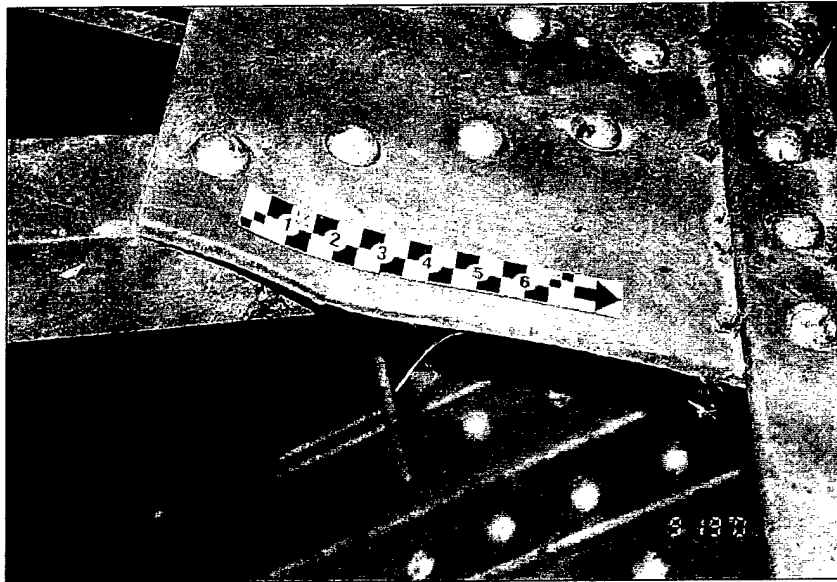
Riveted connections are in good condition with isolated spots of light corrosion. The gusset plate connecting the top left strut and top bracing to the top girder is deformed approximately  $1/4$ -inch. See photo 25. It is unclear if this was caused by stress in the plate or something being dropped from above. The bolt holes at the connection of the top girder and the top seal have been flame cut to a slotted hole. This is typical across the top seal. See photo 26.

*Photo 25 – Gusset plate at top strut connection to top girder.*

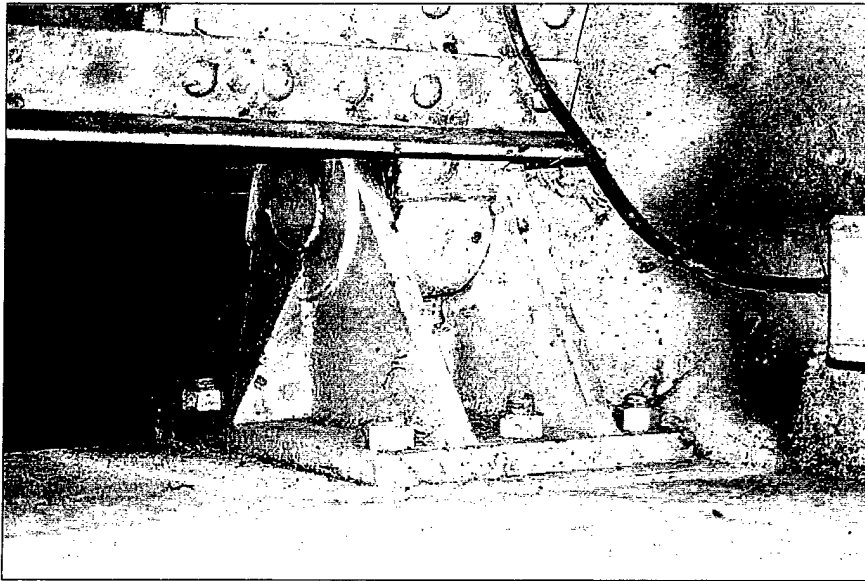
The trunnion consists of a 3-1/2 inch pin contained by a 1-1/2 inch thick bushing. All components of the trunnion are in good condition with only light surface corrosion at isolated locations. See photo 27.

*Photo 27 – Left trunnion connection.*

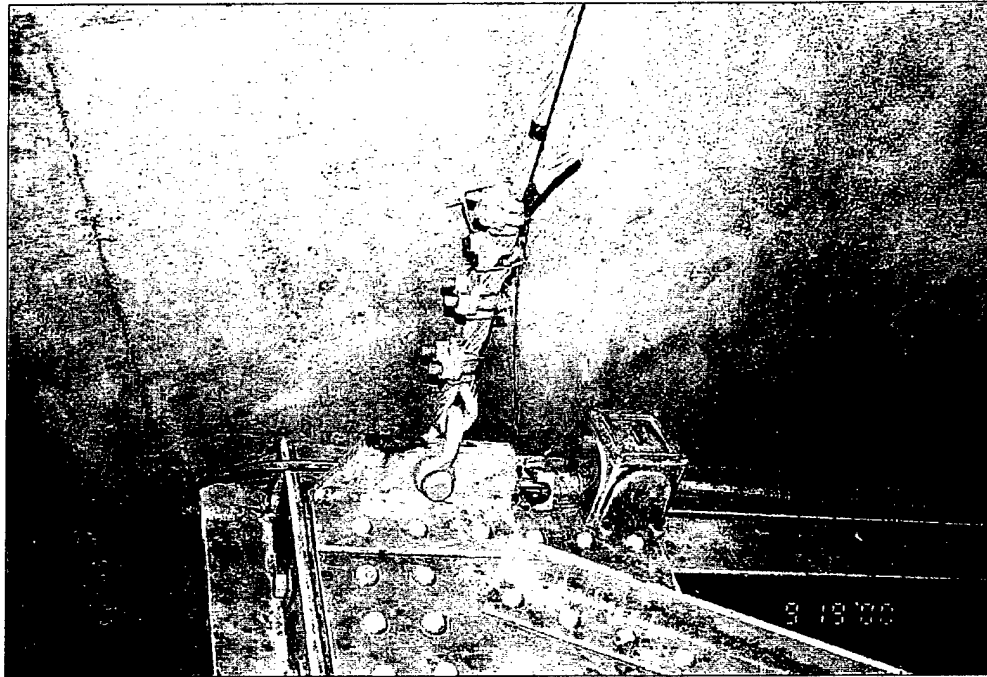
Electric side seal heaters have been installed on the gate at some time in the past. There is no indication of the heaters on the provided as-built plans. No determination as to the working condition of the heaters was made. See photo 28.

*Photo 28 – Seal heater installed on gate.*

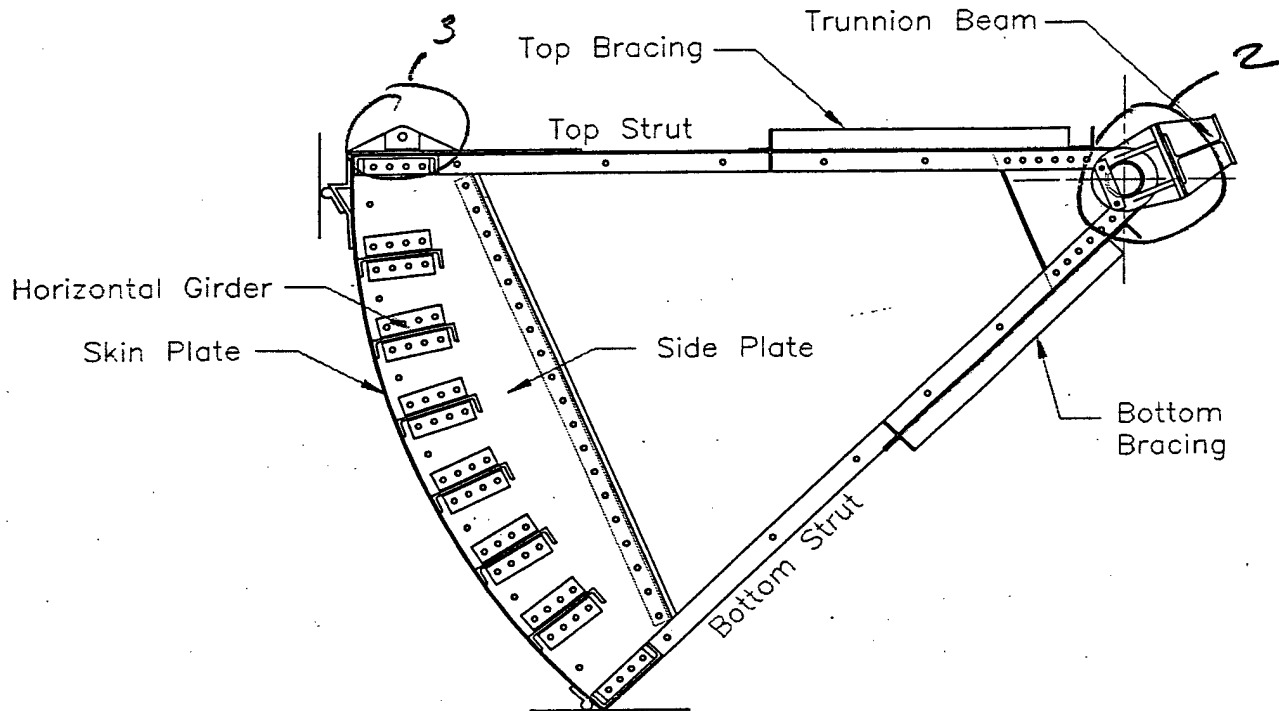
Gate No. 1 Left Elevation B-B

8. Trunnion 9. Trunnion light surface corrosion

10. light Corros. @ Bolts & connection

12. Light cracking in CT SIDE SEAL

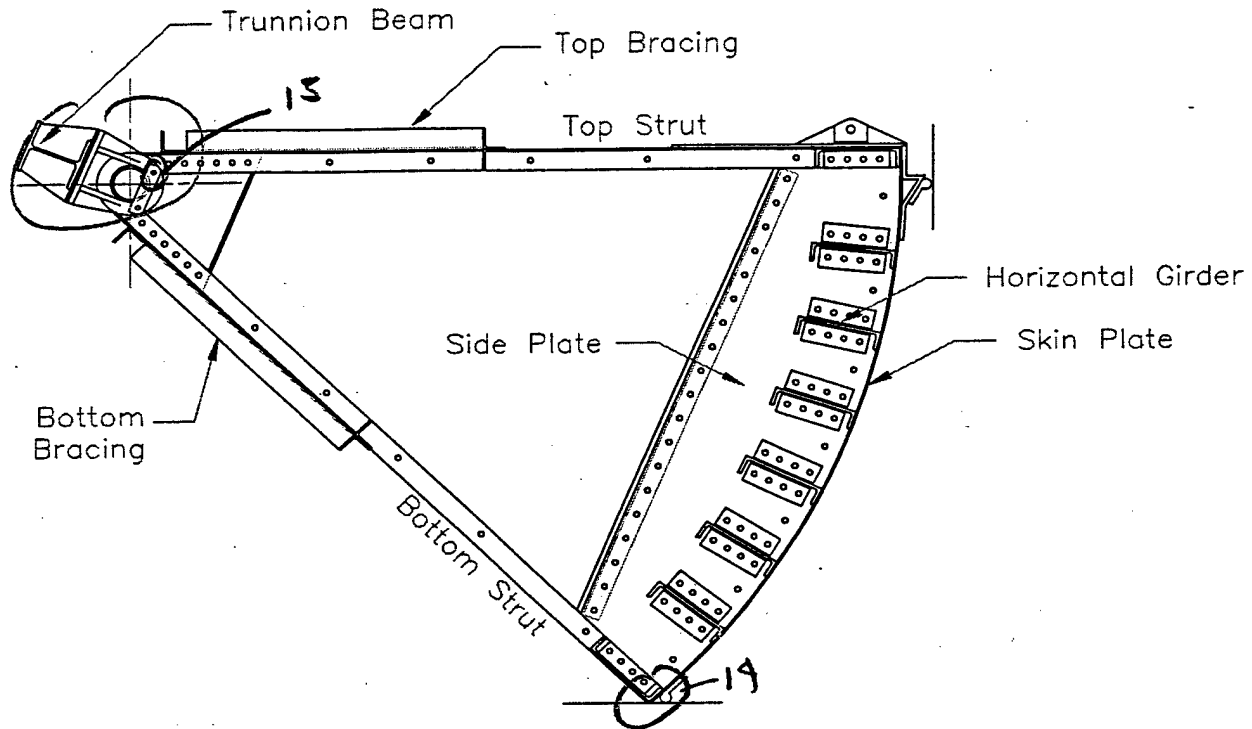
Gate No. 1 Right Elevation A-A

1. GATE # 2. LFT Trunnion (good condition, some chipped paint)  
 3. LFT. Polly system, Light Rust Heavy Grease

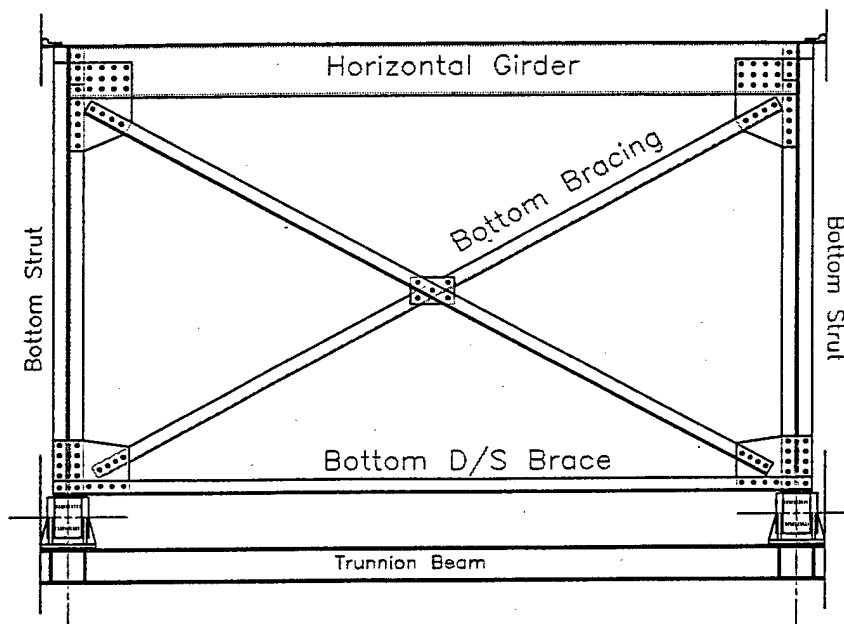
Gate No. 1 Bottom Bracing

7: light rust w/chipped PNT.

10. Bolts to bot seal EVERY other bolt missing

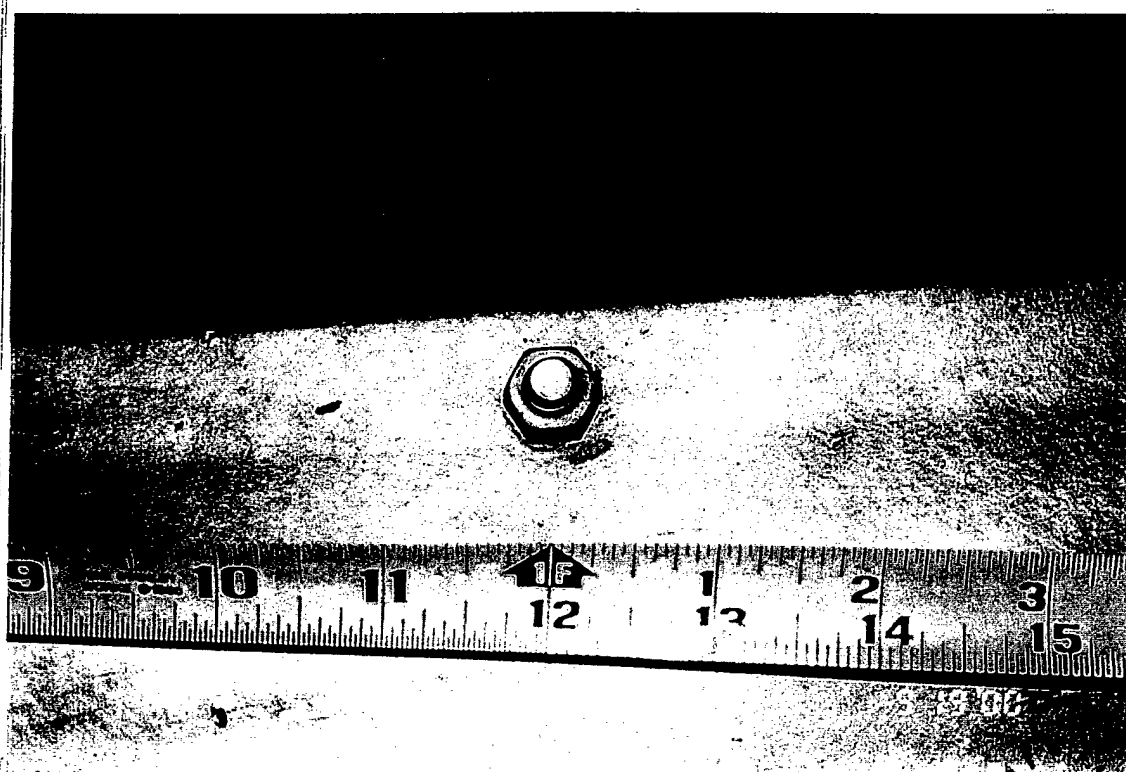
Armco 6'x14' Gate  
 Bottom upstream end Strut 1, left  
 side of gate. Light corrosion on  
 gusset plate and bolts.

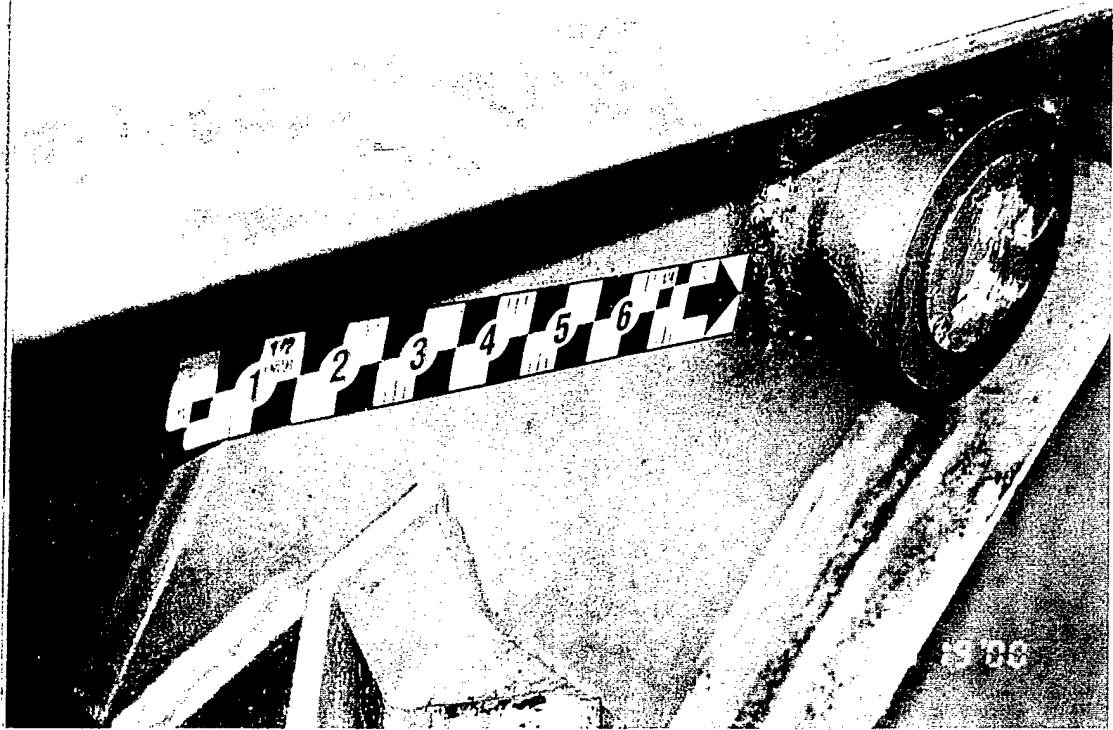
Armco 6'x14' Gate  
 Typical condition of bolted  
 connections.

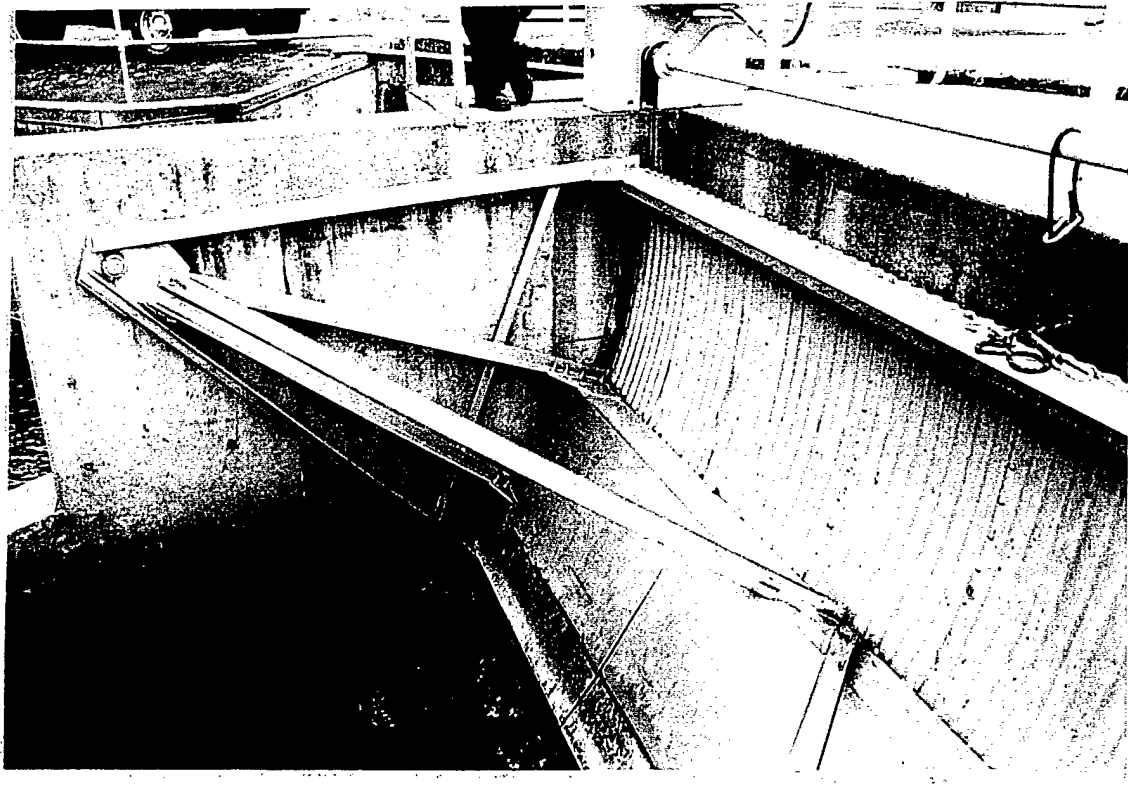
Armco 6'x14' Gate  
Left trunnion looking downstream.  
Light corrosion on embedded  
trunnion assembly.

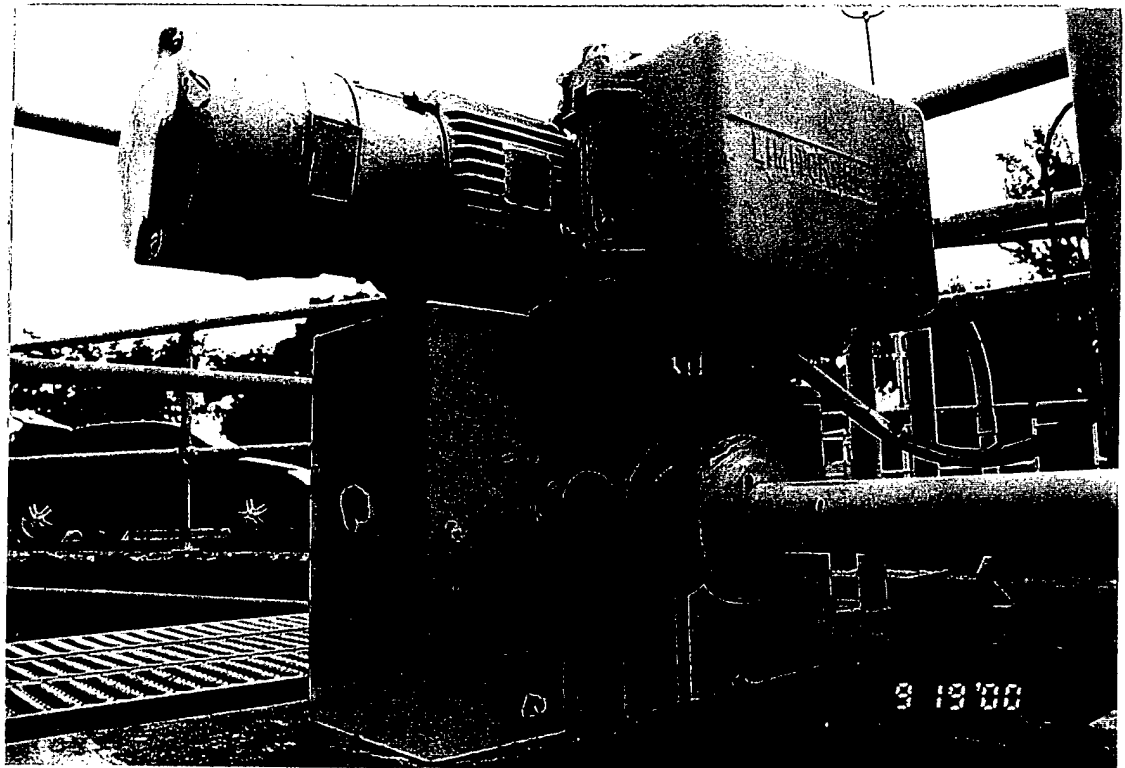
**Armco 6'x14' Gate**  
Left side, hoist torque tube, support  
bearing and take-up drum. Light  
corrosion on drum.

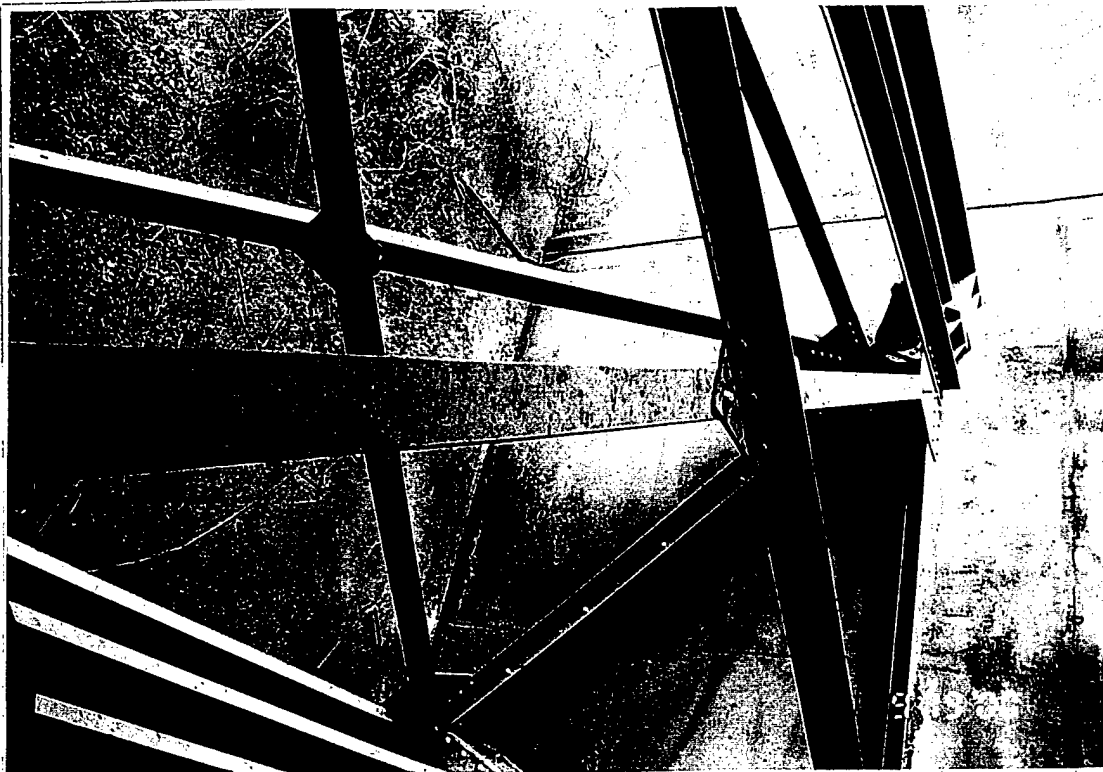
**Gate 1 - 8'x18'**  
Top of top horizontal girder and right  
hoist reduction pulley. Note: missing  
paint on pulley at previous location of  
hoist connection

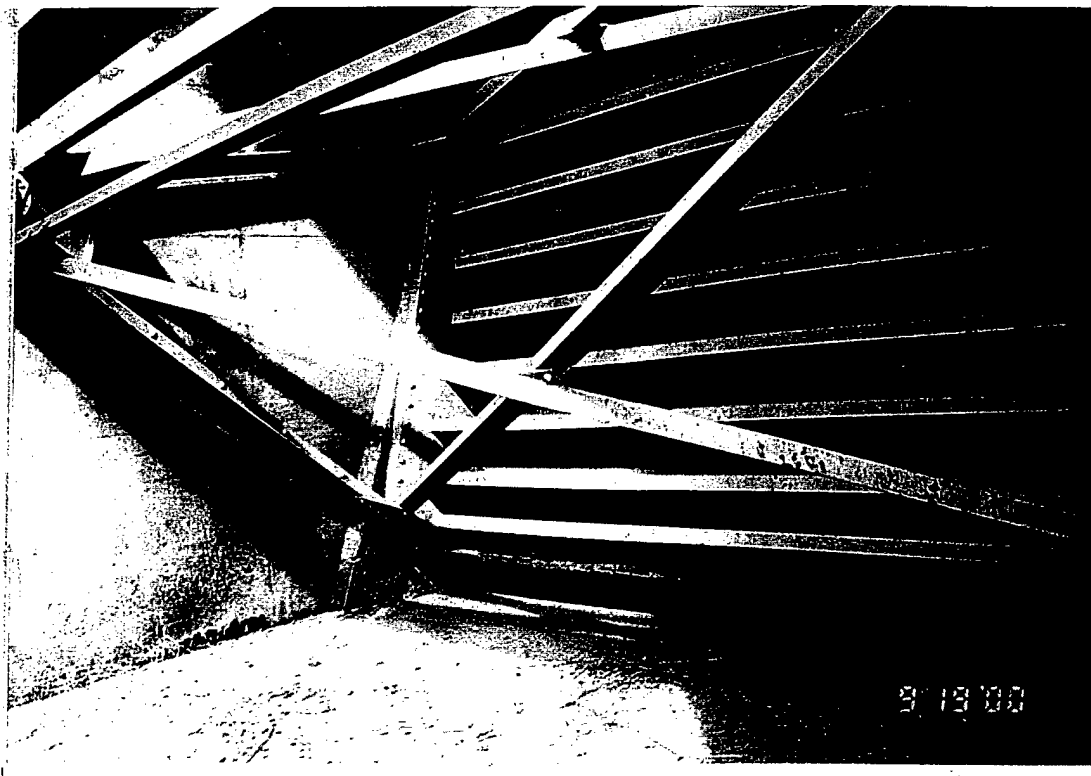
Gate 1 - 8'x18'  
Bottom right corner of gate. Light to  
moderate corrosion and deformations  
on bottom strut. Splintered timber  
bottom seal bumper.

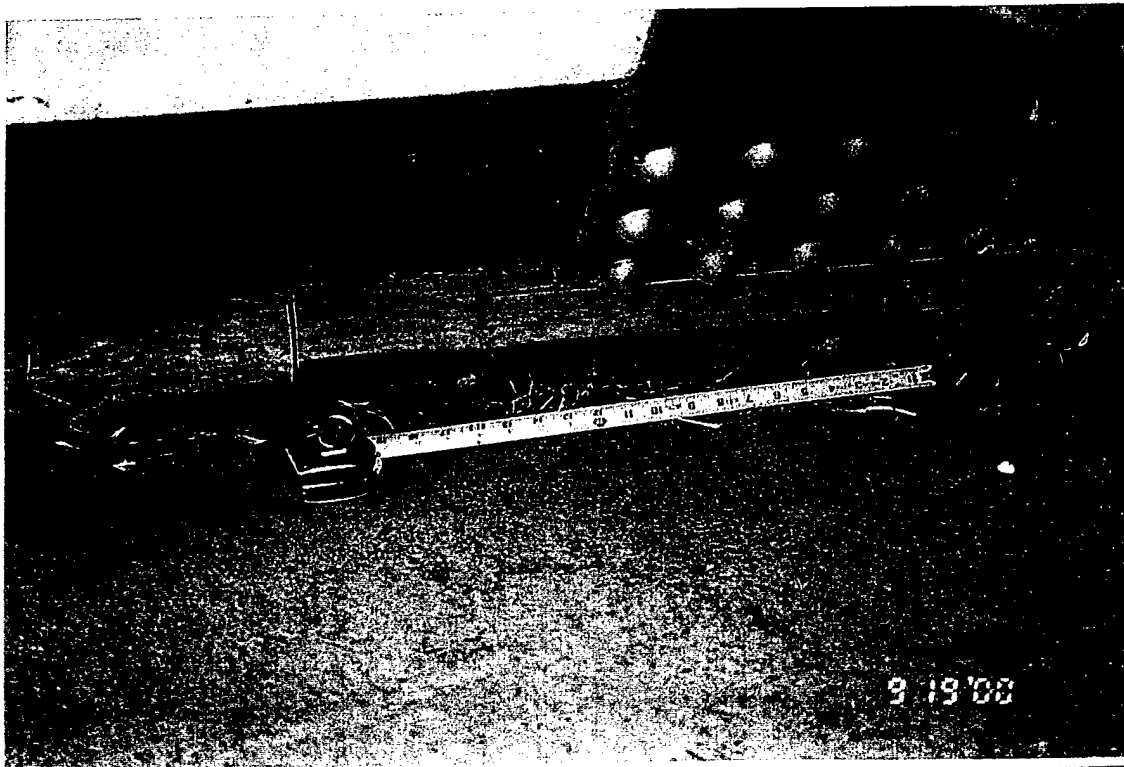
Gate 2 - 8'x18'  
Paint peeling, delamination and light  
corrosion on cross bracing, typical.

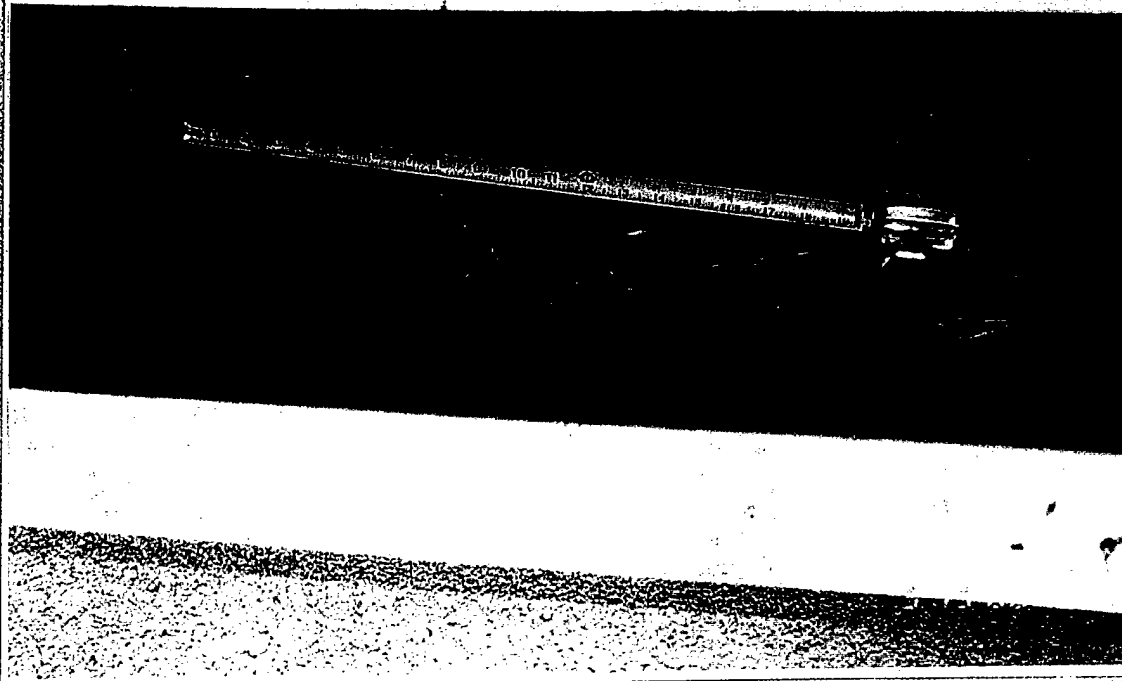
**Gate 2 - 8'x18'**  
Close-up, bottom left side of gate at  
timber bumper. Splitting at end of  
bumper, light to moderate corrosion  
on bottom strut.

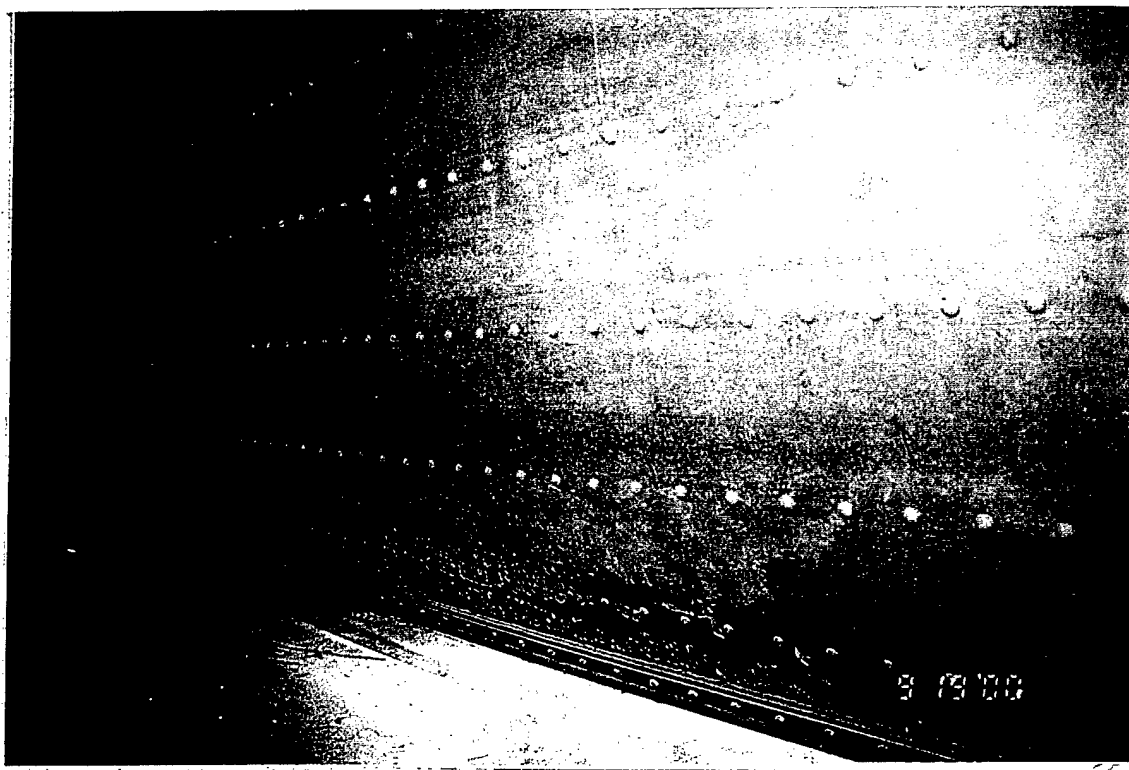
Top of trunnion beam. Delaminated  
paint, light corrosion, debris and no  
drainage

- Drainage holes should be provided for the horizontal girders which are rotated to cause ponding against the skin plate. The drain holes should be 1-inch in diameter and spaced at approximately 24-inches along the girders. The edge of hole should be located approximately 1/2-inch from the girder flange. The holes should be drilled, not flame cut (the use of a mag-drill is recommended). If flame cut holes are the only available option, the edges of the holes should be reamed smooth.

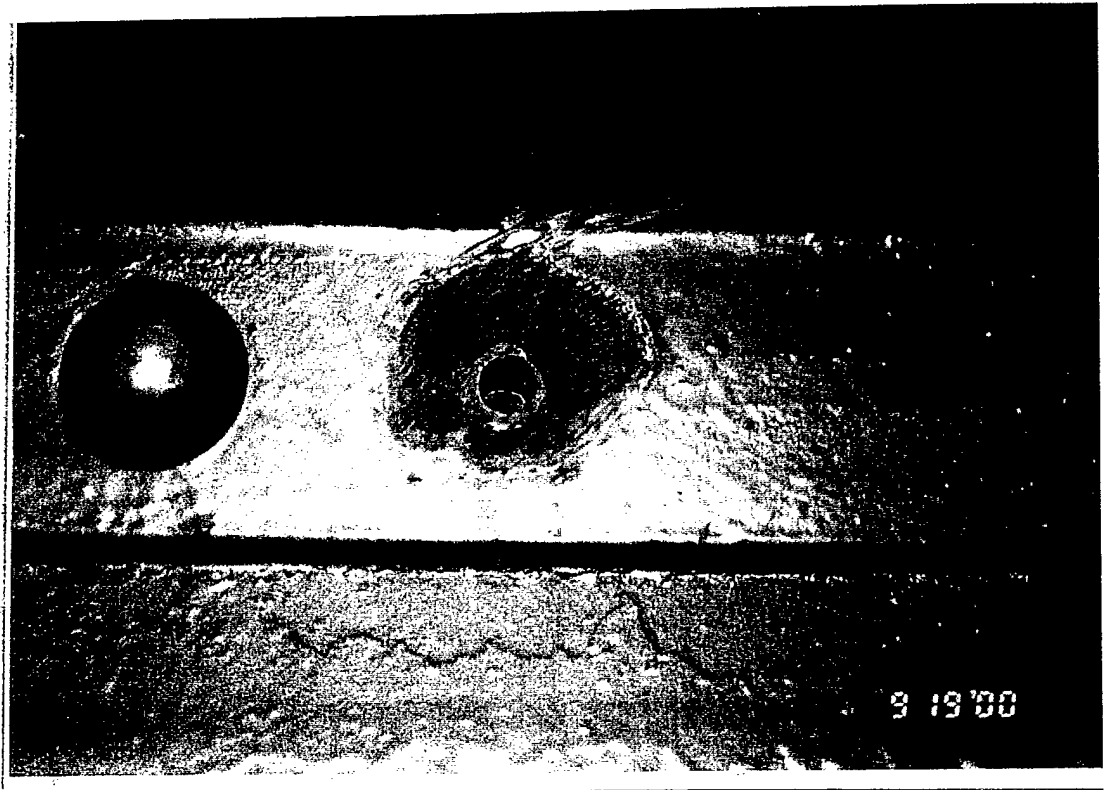
**Gate 3 - 8'x18'**  
Top seal angle connection bolts,  
approximately center of gate. Bolt is  
loose and can be turned by hand.

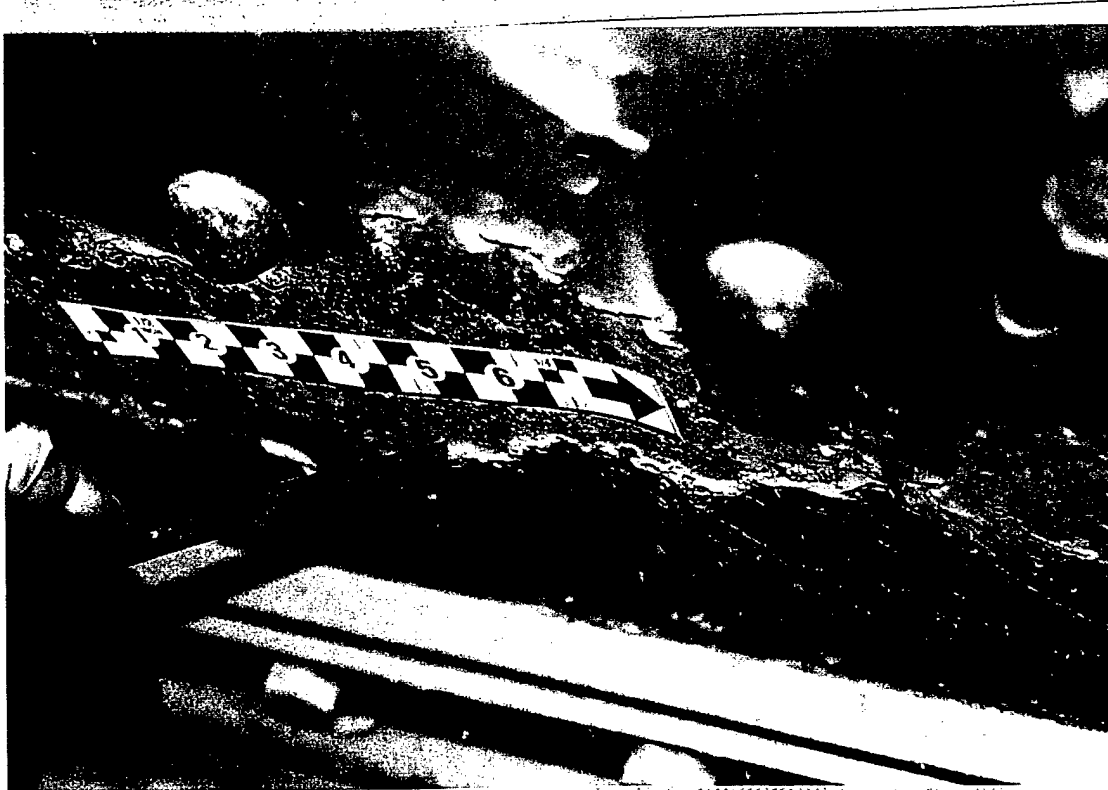
Gate 3 - 8'x18'  
Close-up of skin plate at bottom seal.  
Light to moderate corrosion.

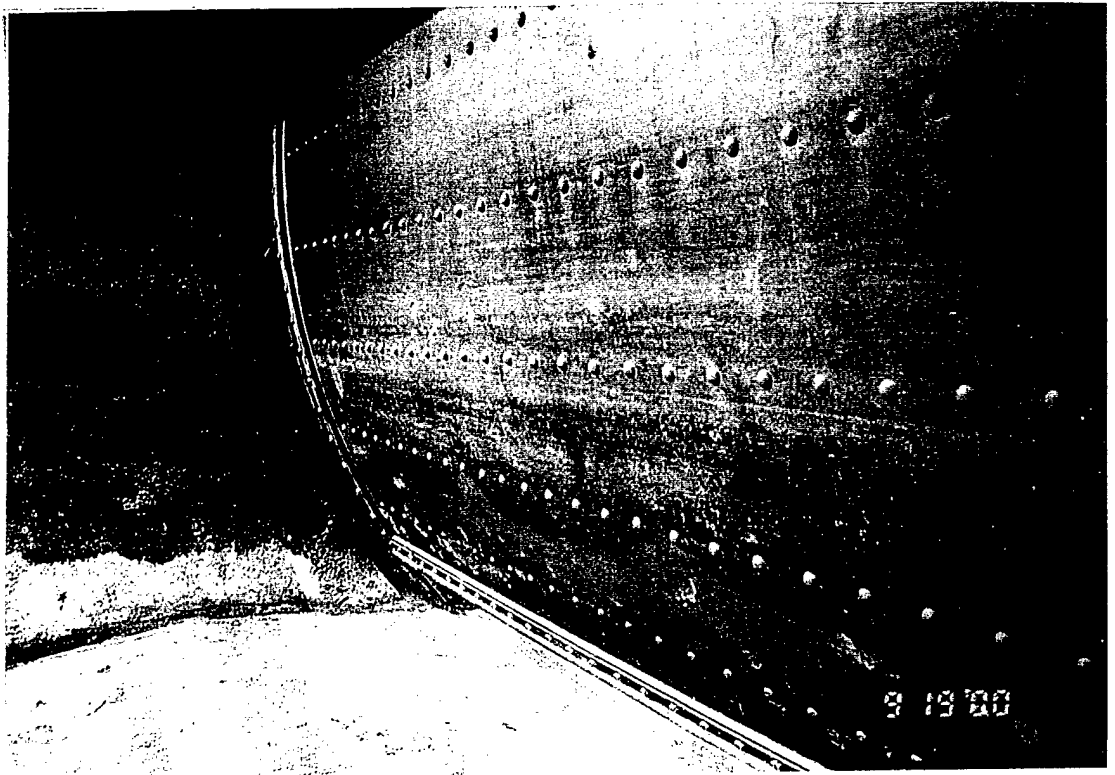
Gate 3 - 8'x18'  
Close-up of skin plate at bottom seal.  
Light to moderate corrosion.

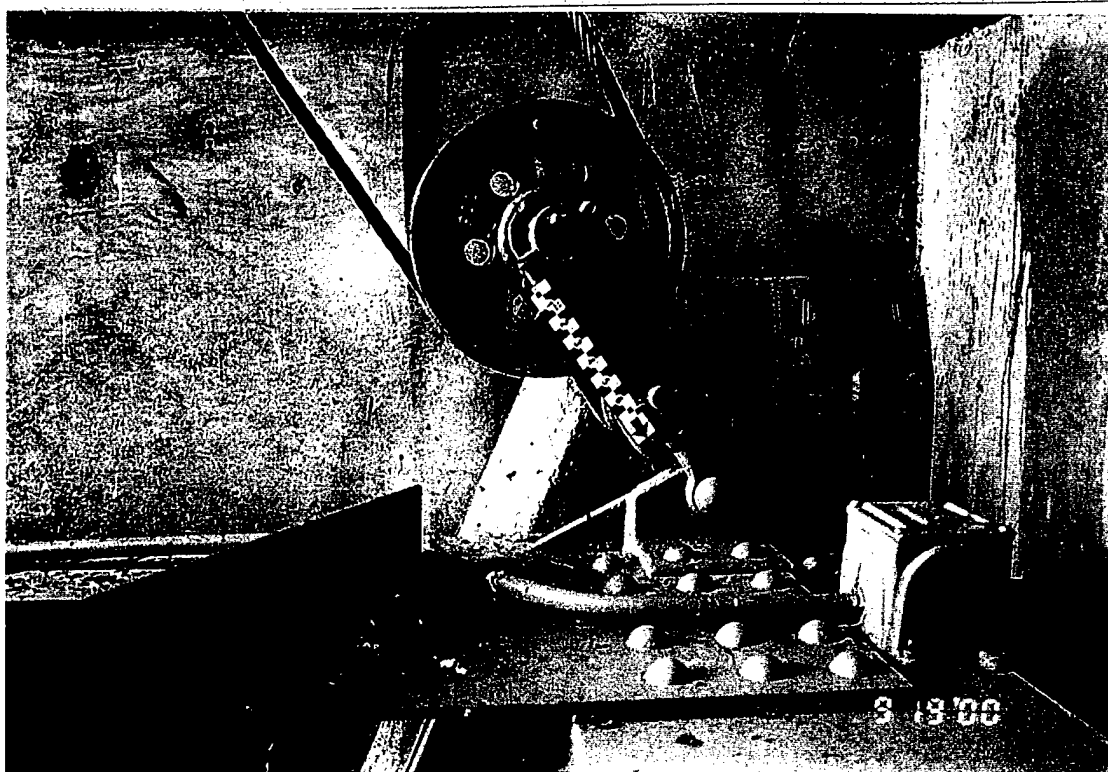
Gate 4 - 8'x18'  
Left hoist reduction pulley. Note:  
missing paint on pulley at previous  
location of hoist connection.
